Experimental Investigation of Reinforced Concrete and Hybrid Fibre Reinforced Concrete Shield Tunnel Segments Subjected to Elevated Temperature

This paper presents a comprehensive experimental study on the comparative behaviour of the reinforced concrete (RC) and the hybrid fibre reinforced concrete (HFRC) shield TBM (Tunnel Boring Machine) tunnel lining segments exposed to fire. The tests were conducted using a newly developed test facility, which is capable of accommodating different mechanical loading and boundary conditions under different fire scenarios. Six RC segments and six HFRC segments were tested to **the standard Eurocode HC (Hydrocarbon) curve**, while two reference specimens, one for each type, were tested in ambient environment to provide benchmark data. Apart from the spalling resistance, the fire effects on the structural behaviour were investigated under different boundary conditions at the segment ends, including free sliding (no horizontal constraint), total horizontal restraint and controlled horizontal reaction. The vertical load capacities were investigated for both under-fire and post-fire scenarios. **The experimental results revealed excellent spalling r

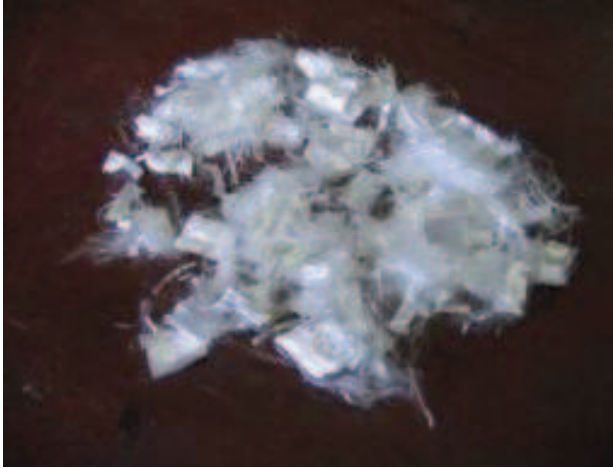
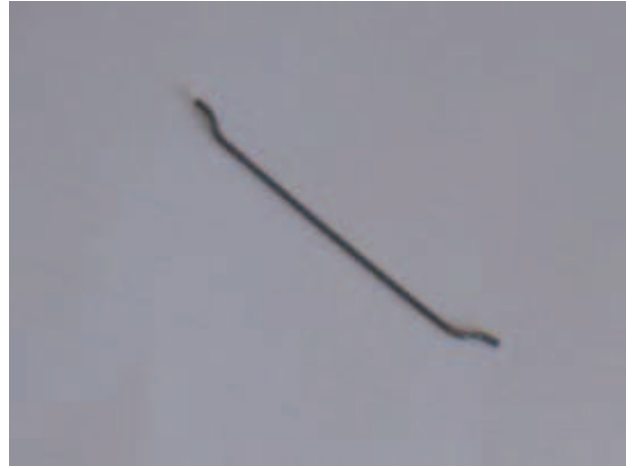
(a) polypropylene fibers

(b) steel fiber

Fig.2. Fibers used in this study

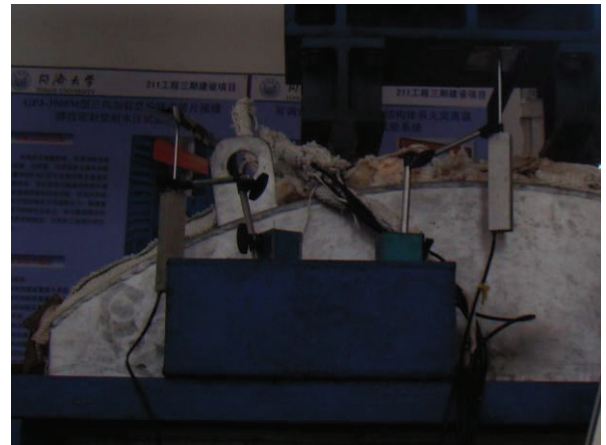
(a) Overall view of the test setup

(b) Insulated specimen on top of furnace

(c) Schematic of the test specimen with variable boundary and loading conditions

Fig.3. Test setup for combined mechanical and thermal loadings and support conditions

Fig.3(b) shows a fully insulated specimen mounted on top of the furnace. A closed heating chamber was formed by two removable cover insulation panels that were situated on the two opposite sides of the segment. Any gaps between the segment and the insulation panels were filled up with ceramic fibres. Hence, the heating condition was considered to represent a uniform, single-face heating of the tunnel linings in fire.

A schematic of the test specimen with variable boundary and loading conditions is shown in **Fig.3(c)**. Totally 14 segment specimens, including 7 pairs of RC and HFRC specimens correspondingly, were tested. For all the test specimens, the two vertical loads (each equal to $1/2 P_v$) were applied by a single hydraulic actuator via a distribution beam; this allowed a simplified control of the applied load. The horizontal action applied at the specimen ends varied such that three different internal load conditions were simulated. As the horizontal

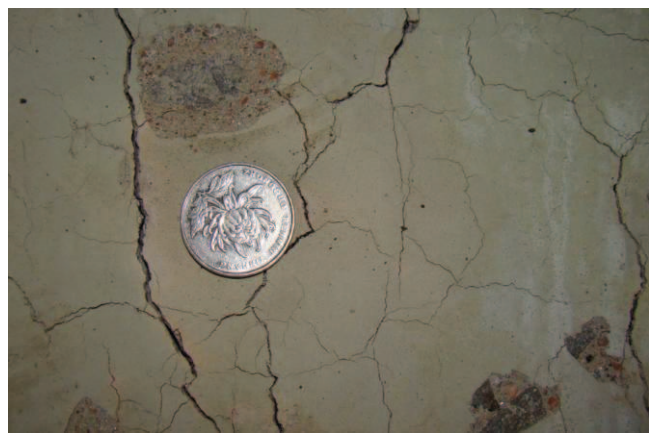
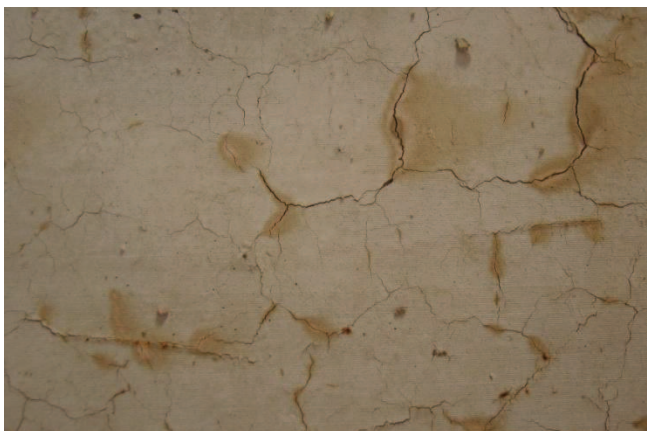
(a) RC segments

(b) HFRC segments

Fig.8. Temperature cracks of RC and HFRC segments under LC1 after fire exposure

Fig.8 shows a comparison of the more detailed crack patterns between typical RC and HFRC specimens under LC1, which represents thermal-induced cracking under a service load condition. The crack widths on the side faces of all specimens were less than 1mm. However, the widths of the main cracks of RC segments on the heated face reached 2~3 mm (as a scale reference the diameter of the coin shown in the photos was 25 mm).

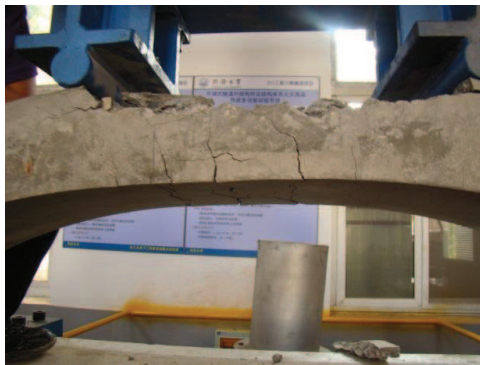
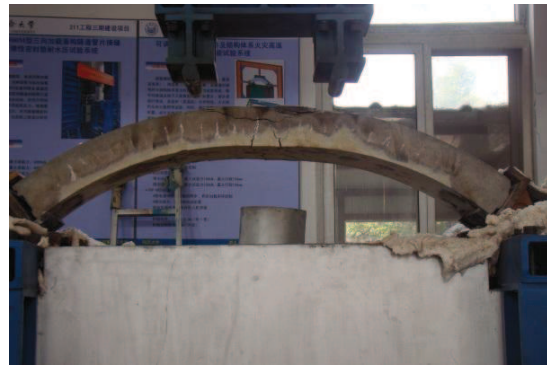
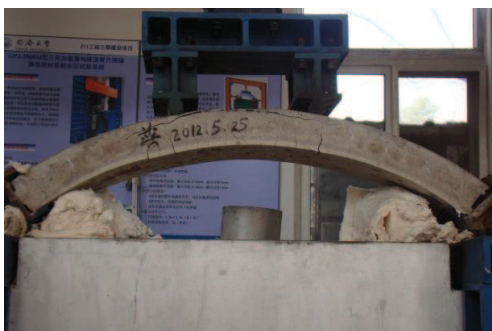
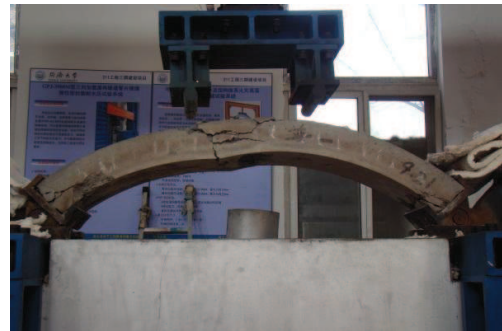
(a1) RC0, Ambient, free slide ($R_H=0$)

(a2) **RC1**, Under fire, free slide ($R_H=0$)

(a3) **RC5**, Post fire, free slide ($R_H=0$)

(b) RC4, Post fire, fixed pin ($d_H=0$)

Fig.10. Failure modes of RC specimens under positive (sagging) moment loading

Inspection of the failure patterns (**Fig.10(a1)-(a3)**) reveals that all the three specimens exhibited a typical compressive bending failure over the mid-span region, with crushing of concrete occurring on the top (compressive) side of the segments, while major flexural cracks also developed. Based on the equilibrium and RC section analysis, it can be found that the tensile steel is slightly over-reinforced, and therefore the observed concrete compressive failure was not surprising. Such a governing mechanism also explains the less significant effect of fire on the overall behaviour and the maximum resistance of these specimens, as the critical compressive concrete on the top side of the specimens was essentially not affected by the fire.

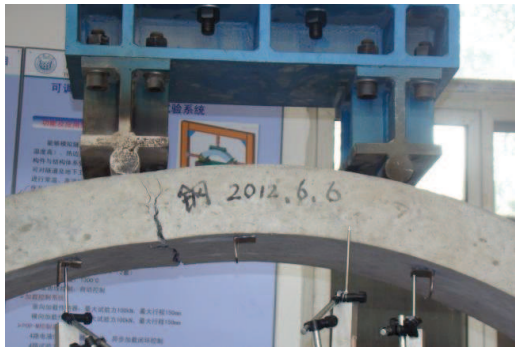
(a1) HFRC0, Ambient, free slide ($R_H=0$)

(a2) HFRC1, Under fire, free slide ($R_H=0$)

(a3) HFRC5, Post fire, free slide ($R_H=0$)

(b) HFRC4, Post fire, fixed pin ($d_H=0$)

Fig.12. Failure modes of HFRC specimens under positive moment loading

as shown in **Fig.12(a3)**. Generally speaking, these specimens exhibited a less ductile behaviour; but unlike the RC specimens discussed earlier, the failure patterns in these HFRC specimens were apparently due to insufficient tensile capacity, i.e. an under-reinforced bending. Recall that the HFRC specimens had only fibre reinforcement and did not have main reinforcing steel bars. As a result, the specimens quickly reached an ultimate state when bending cracks developed due to the insufficient ability of the fibres in withstanding the tensile force under bending.

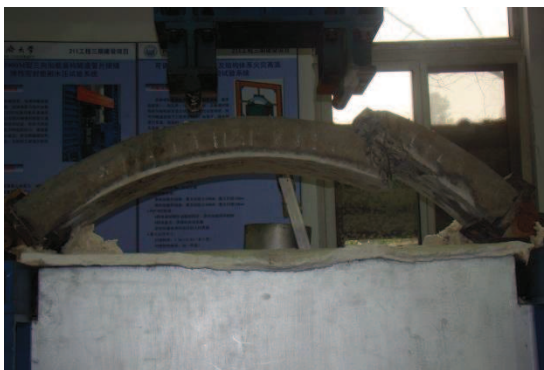
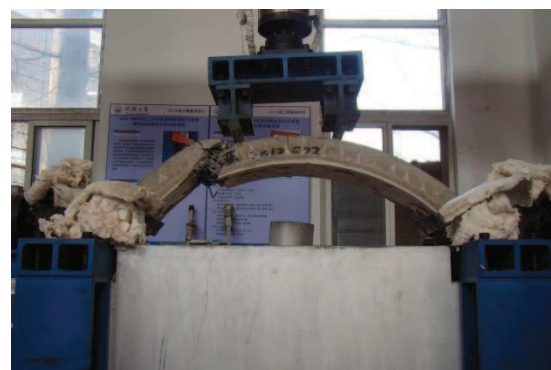
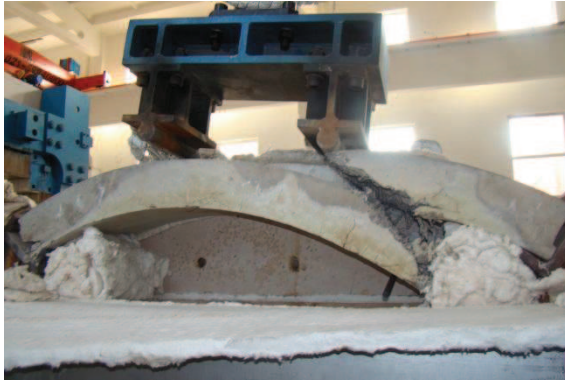
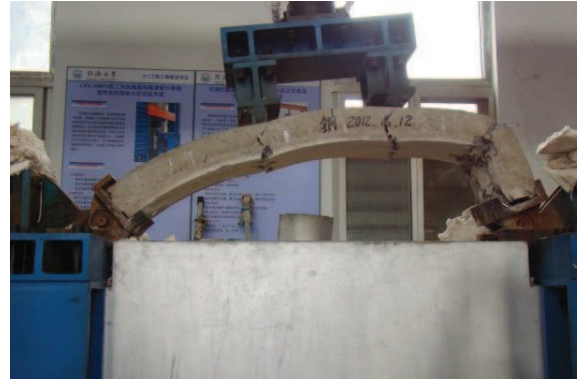
(a) RC2 ($P_v/R_H=1.2$, under fire)

(b) RC6 ($P_v/R_H=1.2$, post fire)

(c) HFRCC2 ($P_v/R_H=1.2$, *under fire*)

(d) HFRCC6 ($P_v/R_H=1.2$, *post fire*)

Fig.15. Failure modes for hogging moment loading cases

modes shown in **Fig.15(a) and (b)**, it is clear that the governing mechanism was due to relatively high shear, resulting eventually in shear failure near the loading point (towards the support). As the tension-shear cracks developed from the inner surface, both the reinforcing bars and the upper concrete along the shear crack were exposed to fire, leading to degradation of their strength under high temperature and hence a substantially reduced overall strength in the under-fire test as compared to the post-fire test, in which case the strength of the reinforcing bars recovered after cooling.

The load-deflection curves for the two HFRC segments are given in **Fig.14(b)**, and the failure patterns are shown in **Fig.15(c) and (d)**. Ignoring the initial settlement, the vertical deflection was also small at first (elastic) stage of loading, and tended to sway into the opposite (upward) direction (particularly in the case of post-fire test). The post-fire test specimen (HFRC6) failed in a rather brittle manner when the maximum load was attained, and the failure mode indicates that it was clearly a shear failure. The failure mode of the under-fire specimen (HFRC2) was somewhat peculiar, featuring a mixed bending failure in different regions of the specimen. This may be explained by the fact that, despite a hogging moment at the mid-span section, the controlled horizontal reaction and the vertical load ratio actually rendered the whole specimen to be under high compression (like an arch), while bending and shear failure could sway either way during the ultimate stage depending on the actual damage development under a significant compression state.
